Extreme Microchemistry¹

Sebastian B. Sparenga
McCrone Research Institute*

These days, people use the word *extreme* to describe just about everything, including extreme-Frisbee, extreme-fishing, and even extreme-walking. Why not microchemistry?! A case example involving the microchemical analysis of glass samples to test for differences between original Pyrex kitchenware and new Pyrex kitchenware will be discussed. The microchemical portion of the procedure requires much practice and patience, hence warranting the “extreme” title.

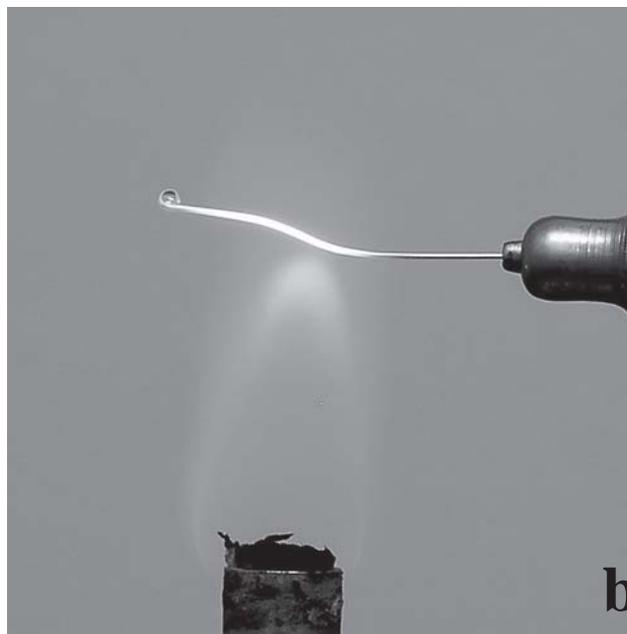
Figure 1: a) Image showing sodium carbonate/pulverized glass combination held in platinum wire loop, b) image showing the loop being heated over alcohol lamp.

A microchemical test for boron was the final step in the analysis of the glass samples. The boron must first be freed from the glass, which was done in the following manner. A portion of the glass was ground with a mortar and pestle until it was the consistency of a fine powder. Next, sodium carbonate was used as a flux to "open" the material. The sodium carbonate was gathered on a platinum wire loop and heated until molten to create a bead in the loop. A portion (about 1/20th of the amount of sodium carbonate) of the glass that had been pulverized into a fine powder was added to the sodium carbonate bead. The combination was heated over an alcohol lamp and kept molten hot for approximately 5 minutes (Figure 1).

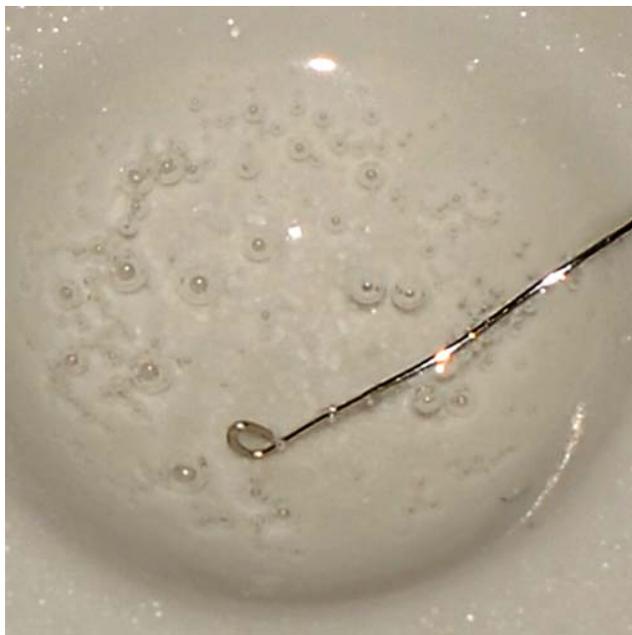
Figure 2: Image of platinum wire loop with bead of sodium carbonate and pulverized glass being submerged into 1:1 dilution of hydrochloric acid.

The bead was then cooled for approximately 1 minute before being placed into a 1:1 dilution of hydrochloric acid in a spot plate (Figure 2).

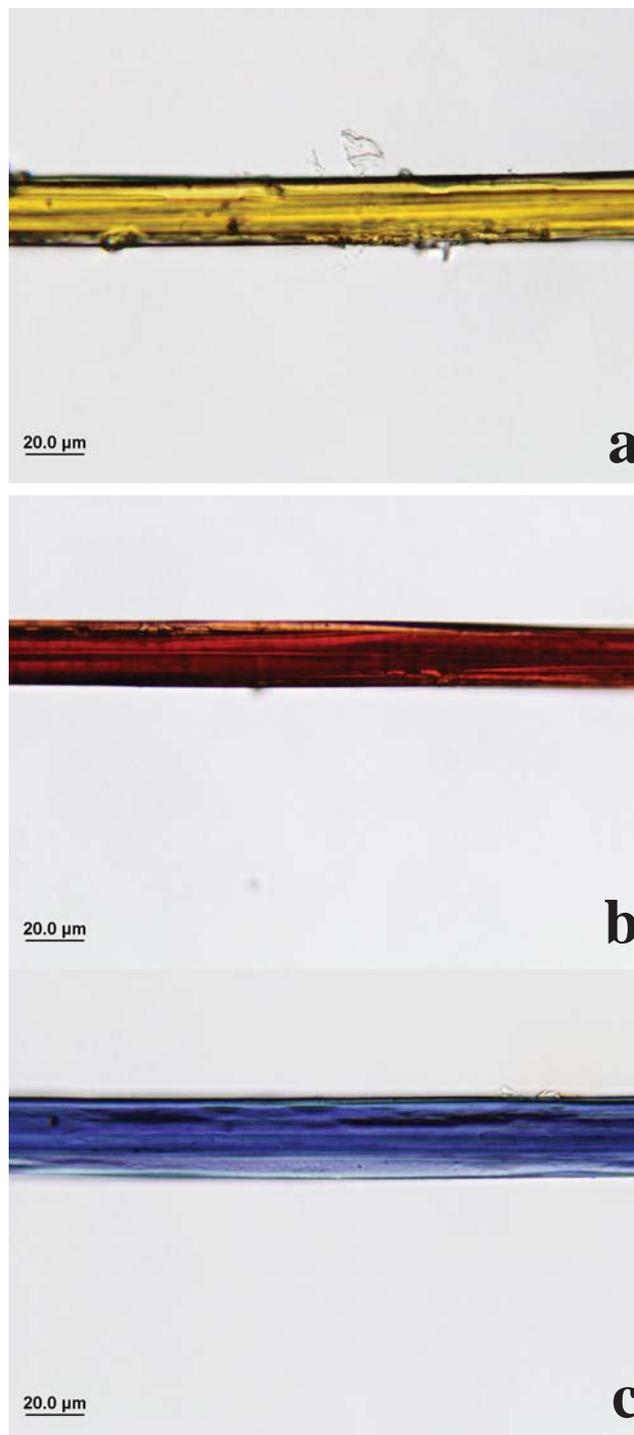
Figure 3: a) Plane polarized light image of yellow turmeric fiber, b) plane polarized light image of turmeric fiber after being submerged in test drop and showing red color, indicating possible presence of boron, plane polarized light of fiber in "b" after being treated with 1% sodium hydroxide, c) turning previously red fiber blue as confirmation of the presence of boron.

The fiber remained in the drop until the drop had gone to complete dryness. Once the drop was dry, the fiber was removed and transferred to a new slide, and a coverslip was added. As a preliminary indication of the presence of boron, the yellow fiber showed a red color where it had been immersed in the now-evaporated drop (Figure 3a and b).

To confirm the presence of boron, a dilute base (1% sodium hydroxide) was added to the edge of the coverslip and allowed to run under by capillary action. If boron was present, the red portion of the fiber turned blue on addition of the base (Figure 4c).

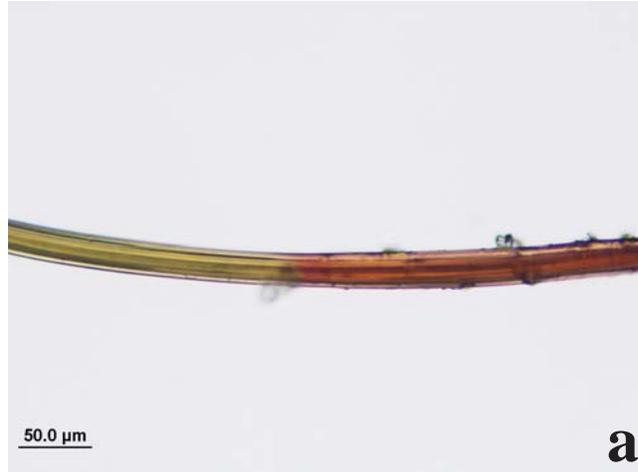
Figure 6: Chemical test for boron (Sample 1). a) Plane polarized light image of the test fiber before addition of sodium hydroxide solution, b) same test fiber after addition of sodium hydroxide solution.

Glass from this sample was prepared for microchemical analysis by freeing and converting boron in the glass to boric acid. The fiber was wetted in the test solution, dried, and viewed under the microscope (Figure 6a). A sodium hydroxide solution was then added to the fiber, which was viewed again under the micro-

scope (Figure 6b). The test confirmed that this sample was positive for boric acid; the fiber developed a red color before and a blue color after addition of the sodium hydroxide. Sample 1 was positive for boron.

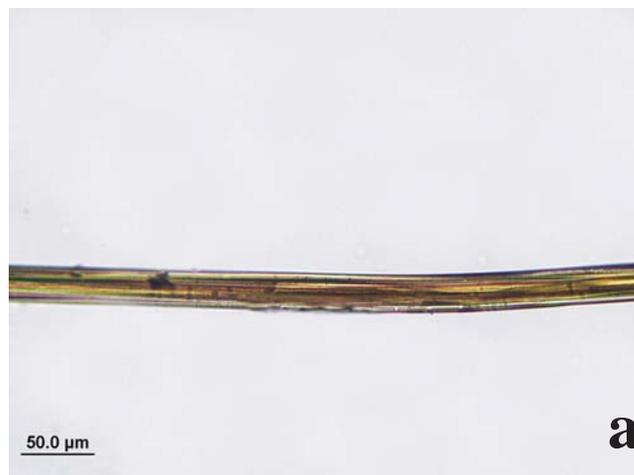
Figure 9: Chemical test for boron (Sample 2). a) Plane polarized light image of the test fiber before addition of sodium hydroxide solution, b) same test fiber after addition of sodium hydroxide solution.

The microchemical test for boron was also performed on Sample 2. Figure 9 shows the results of the test confirming that this sample was negative for boric acid; the fiber developed no red color before and no blue color after addition of the sodium hydroxide. Sample 2 was negative for boron.

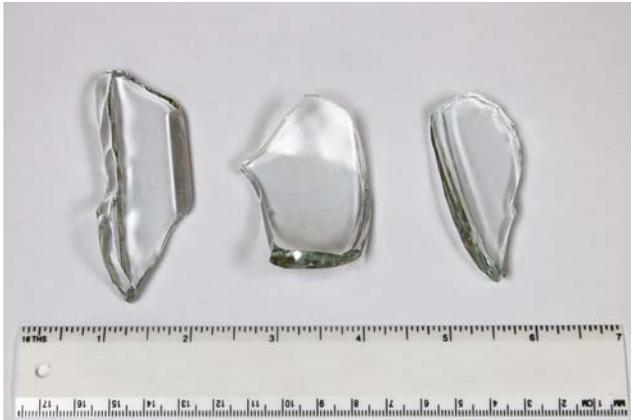
Figure 10: Broken glass fragments as received for analysis (Sample 3).

Sample 3 consisted of three fragments of clear, colorless broken glass (Figure 10). Refractive index mea-

surement gave a value of 1.517 ± 0.001 corrected for 25°C at the sodium D line. This refractive index indicates a soda lime glass.

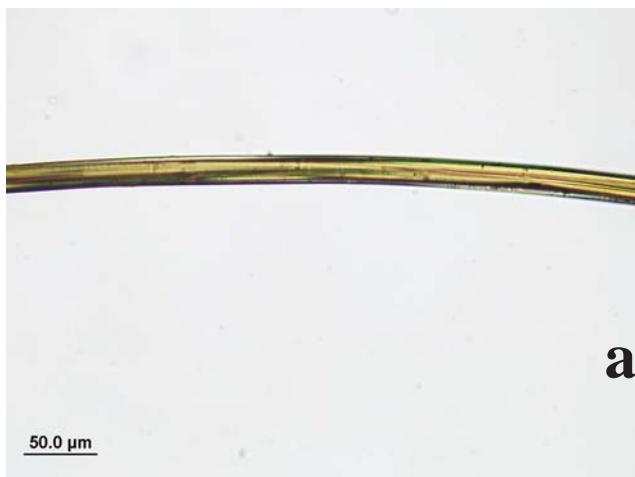
Figure 12: Chemical test for boron (Sample 3). a) Plane polarized light image of the test fiber before addition of sodium hydroxide solution, b) same test fiber after addition of sodium hydroxide solution.

As with Sample 2, the microchemical test for boron confirmed that this sample was negative for boric acid; the fiber developed no red color before and no blue color after addition of the sodium hydroxide (Figure 12). Sample 3 was negative for boron.
