# Investigation of Foreign Substances in Food<sup>1</sup>

Jim Charbonneau

Grocery Manufacturers Association\*

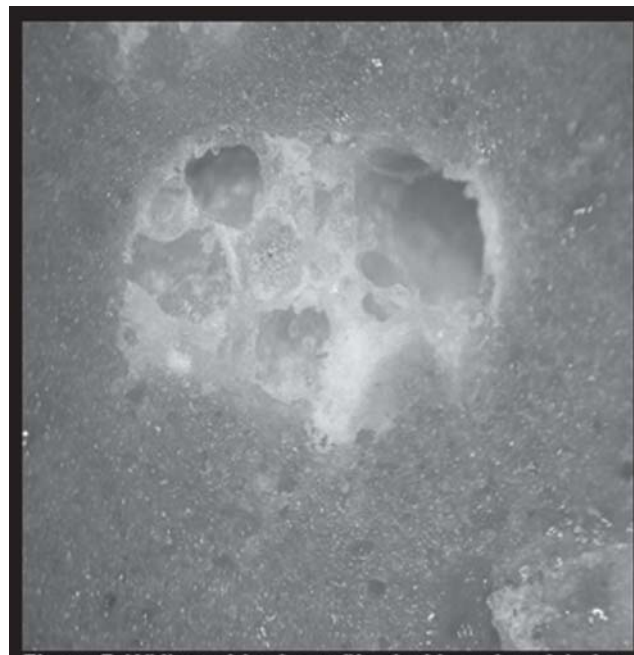
Figure 5 shows white deposits in cavities inside a chocolate bar. Using Lugol's solution, starch was identified by its characteristic black color and was confirmed using FTIR. Using FTIR, tan particles that tested negative for starch, were found to contain protein. Figure 6 shows the FTIR spectra for the starch and protein components compared to standards.

Figure 5: White residue in cavities inside a chocolate bar.

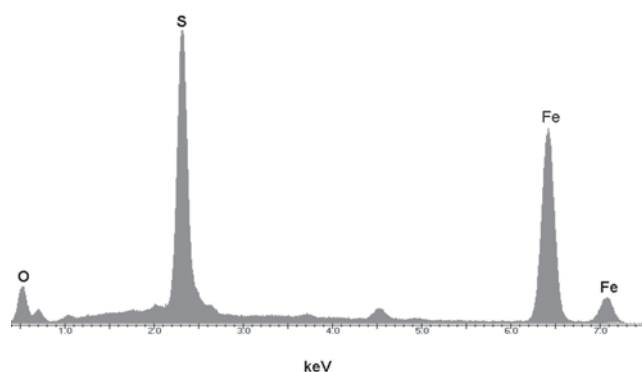
Figure 16: EDS Spectrum of the black deposits on the enamel-coated surfaces of canned chicken broth.

A key goal of metal foreign substance analysis is to track the source of the material. Figure 15 shows black deposits that formed in the headspace of canned chicken broth shortly after processing and storage. Figure 16 shows the EDS spectrum for the deposit. Iron and sulfur were the major peaks and this suggests that the deposits were composed of black iron sulfide. The source of the sulfur that reacted with the iron was garlic added to the product as a flavor enhancer. Figure 17 shows discontinuities in the organic coating that protected the steel from the can and this was the source of the iron in the deposits. Other SEM-EDS investigations of metal container-container-product interactions have been published (2,5).

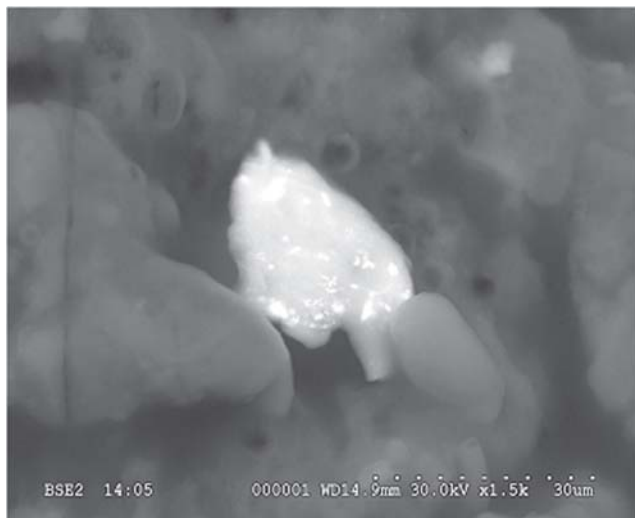
A green discoloration occurred on the surface of sausages. There were a few green spots on each of the sausage links. Figure 18 shows one of the green spots (inside the circle). The stain was present on the surface of the sausage but not on the casing or in the cross section. Using the backscattered electron detector metal-containing particles, 0.01-0.05 mm, in diameter were detected within the stained area. All the particles contained iron in combination with other elements. Figure 19 shows a 30  $\mu\text{m}$  particle found in the stain. Figure 20 shows its EDS spectrum. The particle contains iron and copper. No iron was found at areas outside the stain. The sausages passed through a salt shower to assist in removing the casings from the meat

Figure 19: One of several iron-containing particles in the green stain.

and trace iron contamination was found on individual salt particles. The mechanism for the formation of the green spot may involve oxidation of the meat pigments by interaction with iron from the salt (9). The processor has found the same problem with 2 suppliers of the salt. He'll need to establish specification limit for metal contamination to avoid this problem in the future.

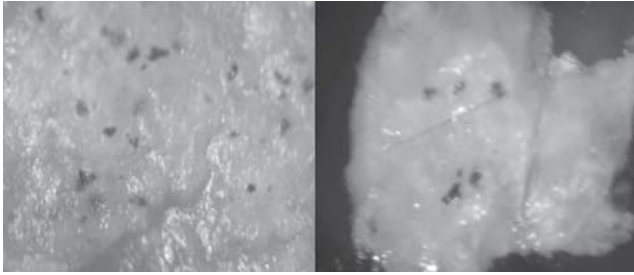
Figure 23: Left photo: Grey discoloration of cheese sauce packaged in a plastic pouch. Right photo: Grey discoloration and a white residue after the washing away the cheese sauce with water.

Cheese sauce packaged in a plastic retort pouch developed a grey discoloration on the food contact surface. Figure 23 shows the grey residue in contact with the cheese sauce and after washing the pouch with water to remove the product. After washing, the grey discoloration and an unknown white substance remained. Figure 24 shows an SEM image of the white material at 180 x magnification. The grey discoloration is not due to particles, but to voids in the white material, up to about 100 microns wide.

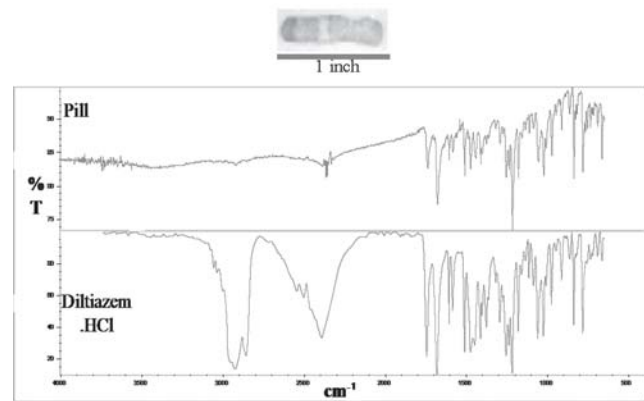
Figure 26: Photo of capsule from a food product, and FTIR spectrum of the incident sample compared to Diltiazem HCl.

A food processor submitted a capsule for analysis. We were instructed not to alter the capsule in any way. SEM and FTIR are non-destructive techniques. The EDS spectrum showed that the pill contained both sulfur and chlorine. Figure 26 shows a photo of the capsule and its FTIR spectrum. The closest match from our FTIR database is diltiazem hydrochloride, known by the brand name Cardizem. It contains both sulfur and chlorine. It functions as a calcium channel blocker. The food processor took the capsule to a pharmacy and was able to find a match. It was learned that someone in the claimant's family was taking this medication. The claim was denied. This was a case of product tampering.
